#### Maintenance History - \$65 Million Investment

#### Scope of Work

# I-75 OVER GODDARD ROAD BRIDGE REPLACEMENT

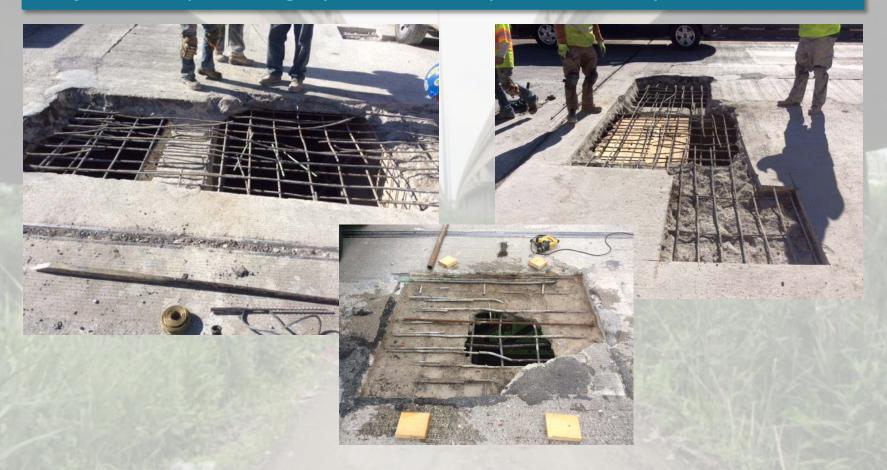
#### Existing Bridge Deck – Poor Condition

#### Major deck patching operations required in the past

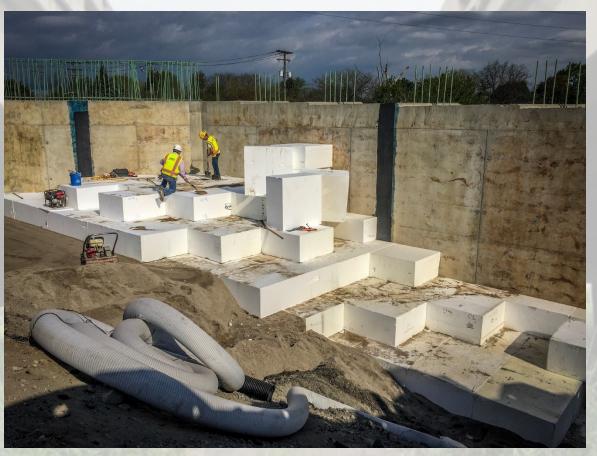
SB I-75 South of Goddard Installing Lightweight Fill

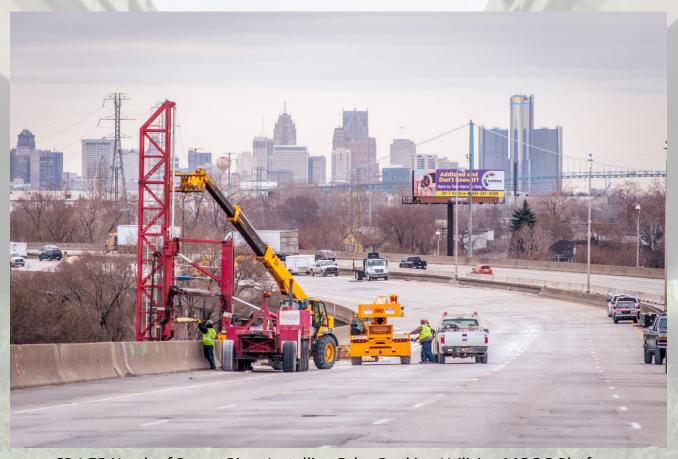
SB I-75 North of Rouge River Installing False Decking Utilizing MOOG Platform

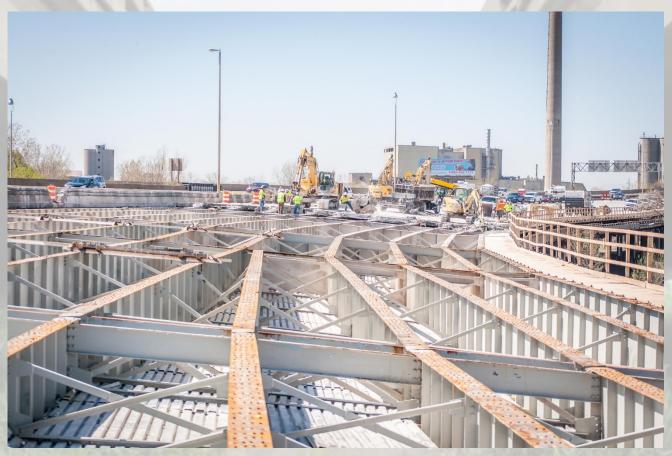
SB I-75 Rouge River Bridge Continuing Bridge Deck Removal

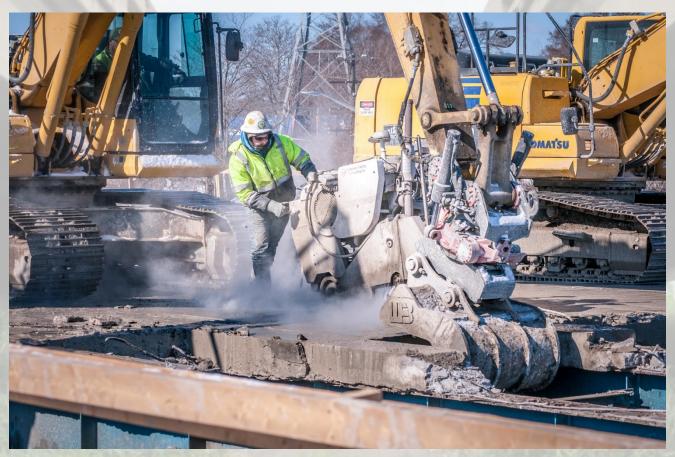
SB I-75 Fort Street Sawing and Slabbing Deck Demolition

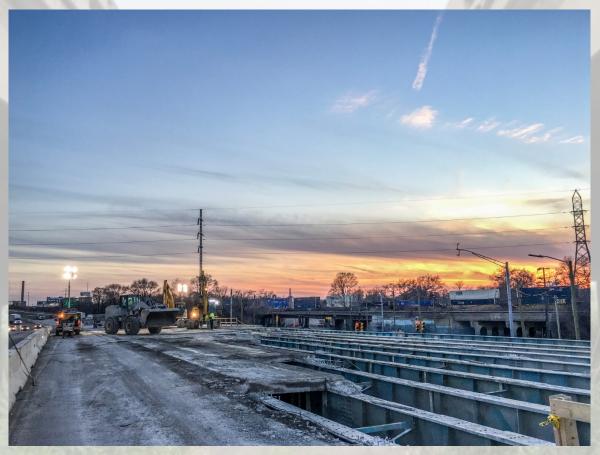
SB I-75 Fort Street Bridge Demolition Continues

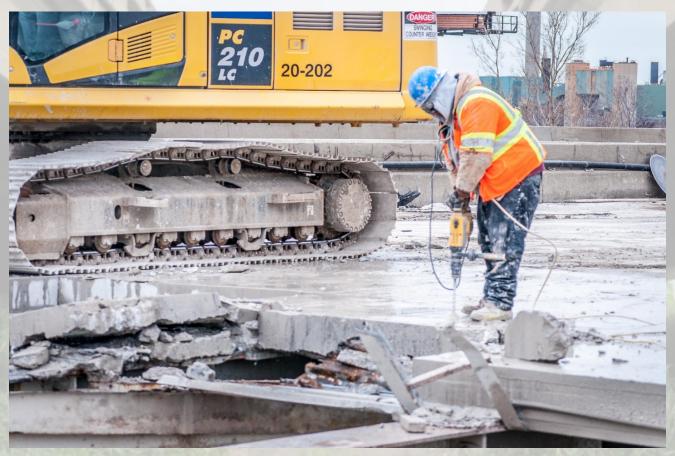
SB I-75 Rouge River Bridge Demolition Continues

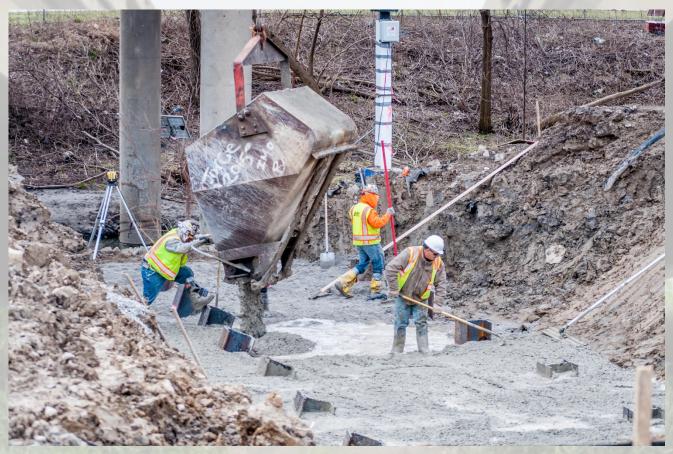
SB I-75 At Sexton-Kilfoil Drain Pouring Sub-footing for South Abutment
